Subsurface damage in alumina induced by single-point scratching

I. ZARUDI, L. ZHANG*, Y.-W. MAI

Center for Advanced Materials Technology, Department of Mechanical and Mechatronic Engineering, The University of Sydney, New South Wales 2006, Australia

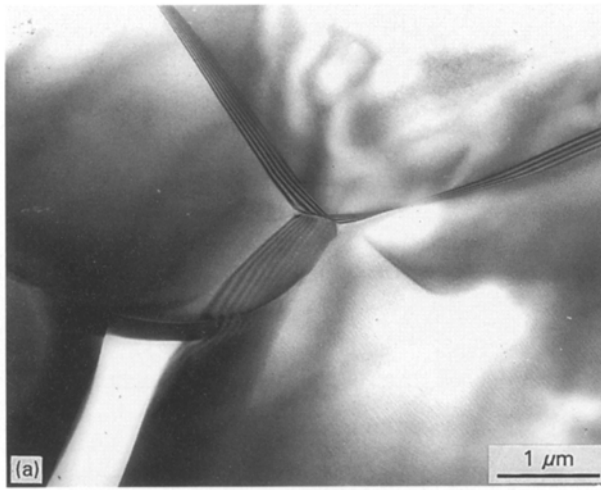
Figure 2 The initial microstructure of alumina after sintering: (a) 25 μm grains; (b) 1 μm grains. Grains are dislocation-free.

Examination of the microstructure revealed that the density of dislocations was extremely low in the coarse-grained ($25\ \mu\text{m}$) alumina. The majority of grains were dislocation-free, Fig. 2a. The porosity of the material was also very clear. A tooth-like structure was, however, observed at the grain boundaries, Fig. 3a, which could be identified as stacking faults. The high density of such faults at the grain boundaries shows the existence of residual stresses in the coarse-grained alumina after sintering.

In contrast, the fine-grained alumina ($1\ \mu\text{m}$) was very inhomogeneous in grain size (Fig. 2b). It varied from $0.8\text{--}5\ \mu\text{m}$ with an average value of $1\ \mu\text{m}$. Porosity was also obvious among the grains. Similar to the coarse-grained alumina, no dislocations were detected inside the grains. However, no tooth-like structure was observed at the grain boundaries (Fig. 3b). This indicates that the residual stresses in the fine-grained alumina due to sintering are much smaller.

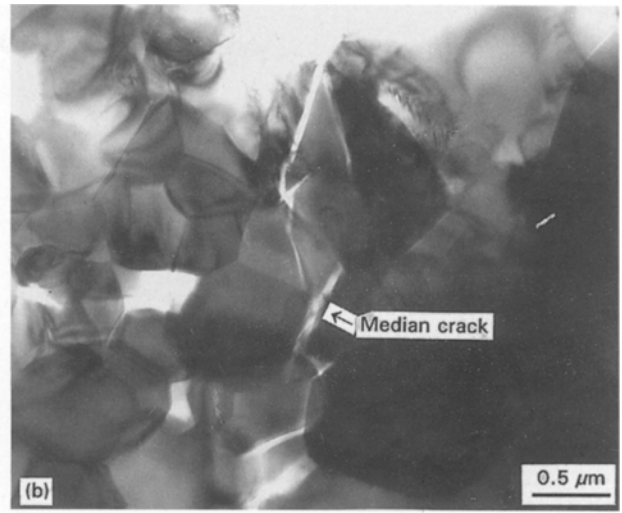
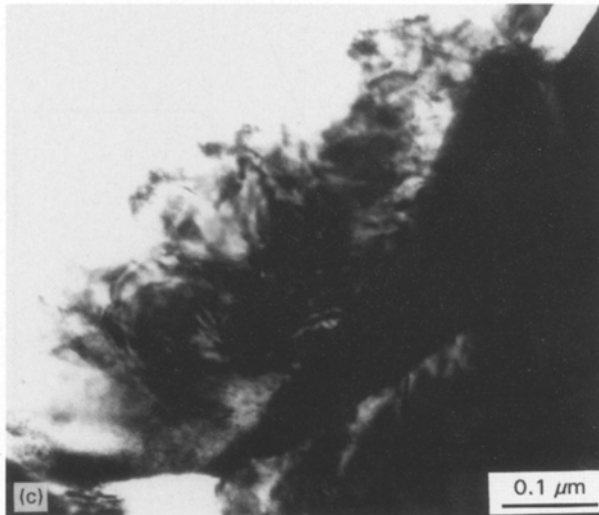
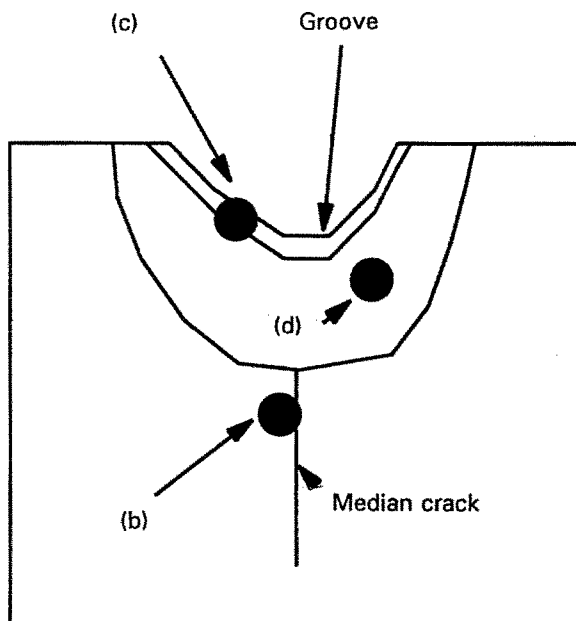
Figure 8 Scratching test with a Vickers indenter on fine-grained alumina. (a) Profile of the groove. The first row of grains is not seen in the picture. (b) Median crack beneath the plastic zone. Note that the median crack begins in the region with the deformed grains and extends past the undeformed grains. (c) The structure of the first deformed grains under the bottom of the groove. (d) Dislocation structure of the third to fifth rows of the grains.

3.3.1.2. Fine-grained alumina. The topography of the scratched surface of the fine-grained alumina is shown in Fig. 7a. The groove was smooth but radial cracks could be clearly seen on the surface near the groove. The included angle of the groove was about 150° (Fig. 8a) which was larger than that of the indenter (136°) because of the elastic recovery of the alumina.

The structure of the plastic or damage zone underneath the groove bottom from which median and radial cracks emanated could be examined in Fig. 8b–d in more detail. The grains in the surface layer of about 1 μm thick were severely deformed (Fig. 8c). The density of dislocations was comparable to that in the coarse-grained alumina. A few grains below, there was a highly deformed layer but with a much lower dislocation density (Fig. 8d), where individual dislocations and dislocation loops could be clearly distinguished. Fig. 8d shows the centre of a dislocation loop located at the boundary of a grain. Accordingly, the dislocation source was at the grain boundary, which could be created by grain sliding via extended loading. No cracks went through the grains. Twins appeared only occasionally. Immediately below this layer (about 5 μm below the surface), a median crack was formed (Fig. 8b) which propagated mainly along grain boundaries. Although the median crack was initiated in the deformed layer, it grew quickly through the region without detectable deformation. No separation of grains took place in the whole process.

dislocations is not favourable for crack resistance and that the appearance of twins would cause additional cracking. Furthermore, the interaction of rhombohedral twins may nucleate macroscopic cracks [21]. The same effect could be observed for intersecting twins with grain boundaries. It then follows that in the fine-grained alumina, the homogeneous distribution of dislocations in the severely deformed layer and the low density of dislocations in the lightly deformed layer cooperatively increase the crack resistance of the material. Hence, the fine-grained alumina has a higher ductile–brittle transition threshold; though it should be noted in the case studied that median/radial cracks do occur (Figs 7a and 8b).
