Subsurface damage in single-crystal silicon due to grinding and polishing

I. ZARUDI, L. ZHANG

Centre for Advanced Materials Technology, Department of Mechanical and Mechatronic Engineering, The University of Sydney, NSW 2006, Australia

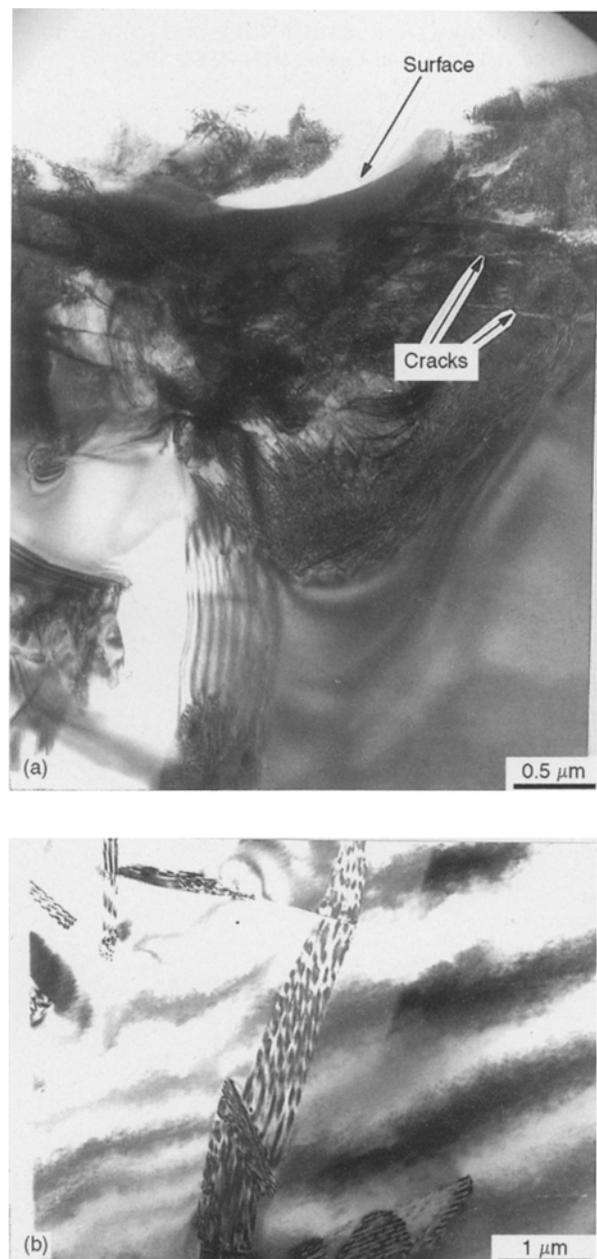
Figure 1 Subsurface damage in single-crystal silicon after grinding with $50\ \mu\text{m}$ abrasive particles: (a) high density dislocations and microcracks; (b) dislocation rosette.

abrasive particles (mean diameter $50\ \mu\text{m}$) is shown in Fig. 1a. Two definite regions can be observed. The first is a highly deformed region of depth $2\text{--}4\ \mu\text{m}$, immediately beneath the ground surface, with an

extremely high density of non-uniform dislocations and a sharp boundary. Many cracks appeared in this zone. The second region outside the above zone has very localized deformation. Only a limited number of linear arrays of dislocations can be observed there, Fig. 1b. These arrays are usually called rosettes [3], which have also been found in some indented materials. These arrays of dislocations develop further along certain easy slip directions and are stopped by pile-ups [4]. The depth of this zone is about $16\text{--}20\ \mu\text{m}$. Such plane dislocation arrays usually serve as stress concentrators [5] and therefore are extremely undesirable from the point of view of crack prevention, because cracks are often initiated along such dislocation arrays. Both of the above deformed regions must be removed in the next grinding/polishing operation in order to obtain a real damage-free surface and subsurface.

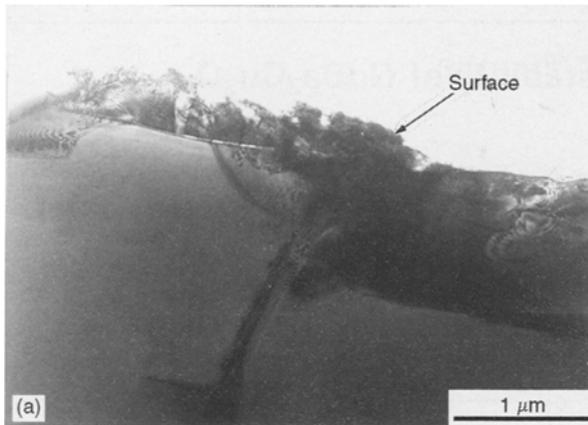
Figure 2 Variation of subsurface damage with processing conditions: (a) after grinding with $5\ \mu\text{m}$ abrasive particles; (b) after grinding with $1\ \mu\text{m}$ abrasive particles; (c) after polishing.

After grinding with $5\ \mu\text{m}$ abrasives, the depth of the first damaged zone reduces to $0.5\ \mu\text{m}$ (Fig. 2a). In addition, slipping bands in the second region occur occasionally and the length of the rosettes reduces to $2\ \mu\text{m}$. Thus the total depth of subsurface damage is $1\text{--}3\ \mu\text{m}$. After fine grinding with $1\ \mu\text{m}$ abrasives, the subsurface damage is still quite obvious in spite of the fact that the surface is reflecting (Fig. 2b) and the depth of the first and second damaged regions are reduced to 0.25 and $1.25\ \mu\text{m}$, respectively.
